Limited Visual Dam Safety Inspection Summary Report

MA-080

Reservoir 60

May 2006

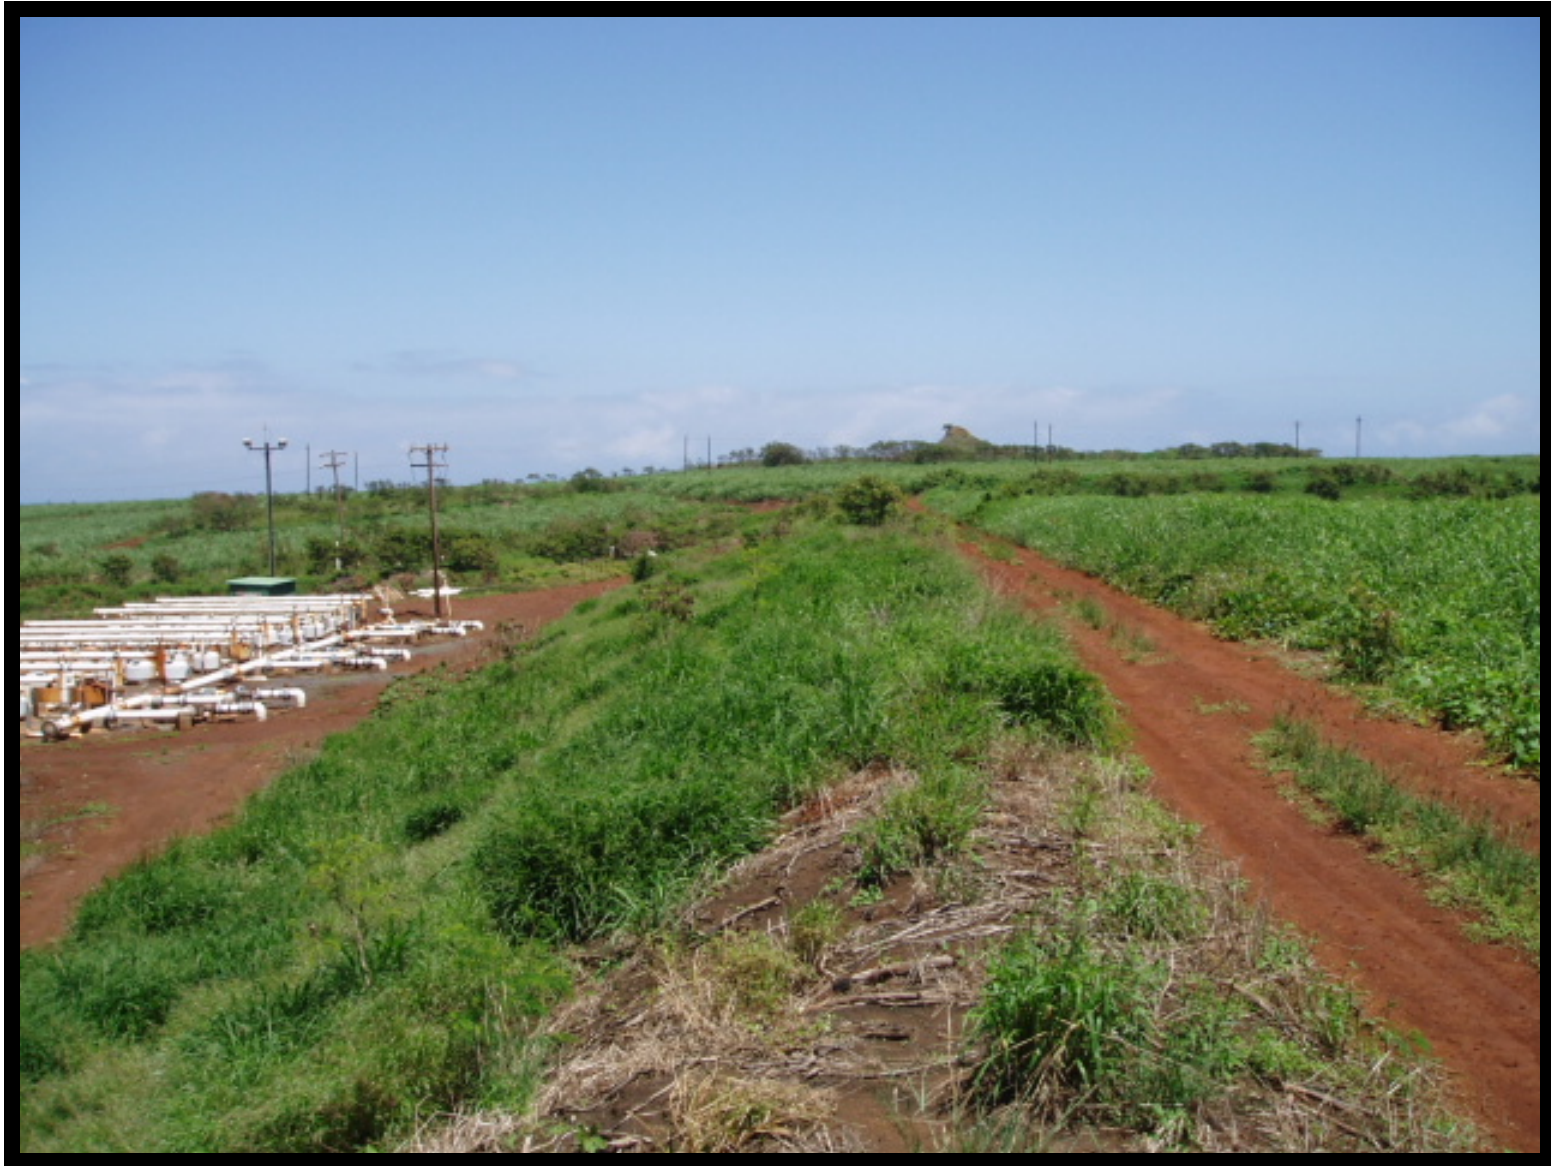
080 crest

- a. The dam crest appeared to be in fair to poor condition and requires corrective action.
- b. Portions of the crest were not visible due to high grass and bush vegetation. Clear high vegetation and maintain low to enable easy visual inspection.

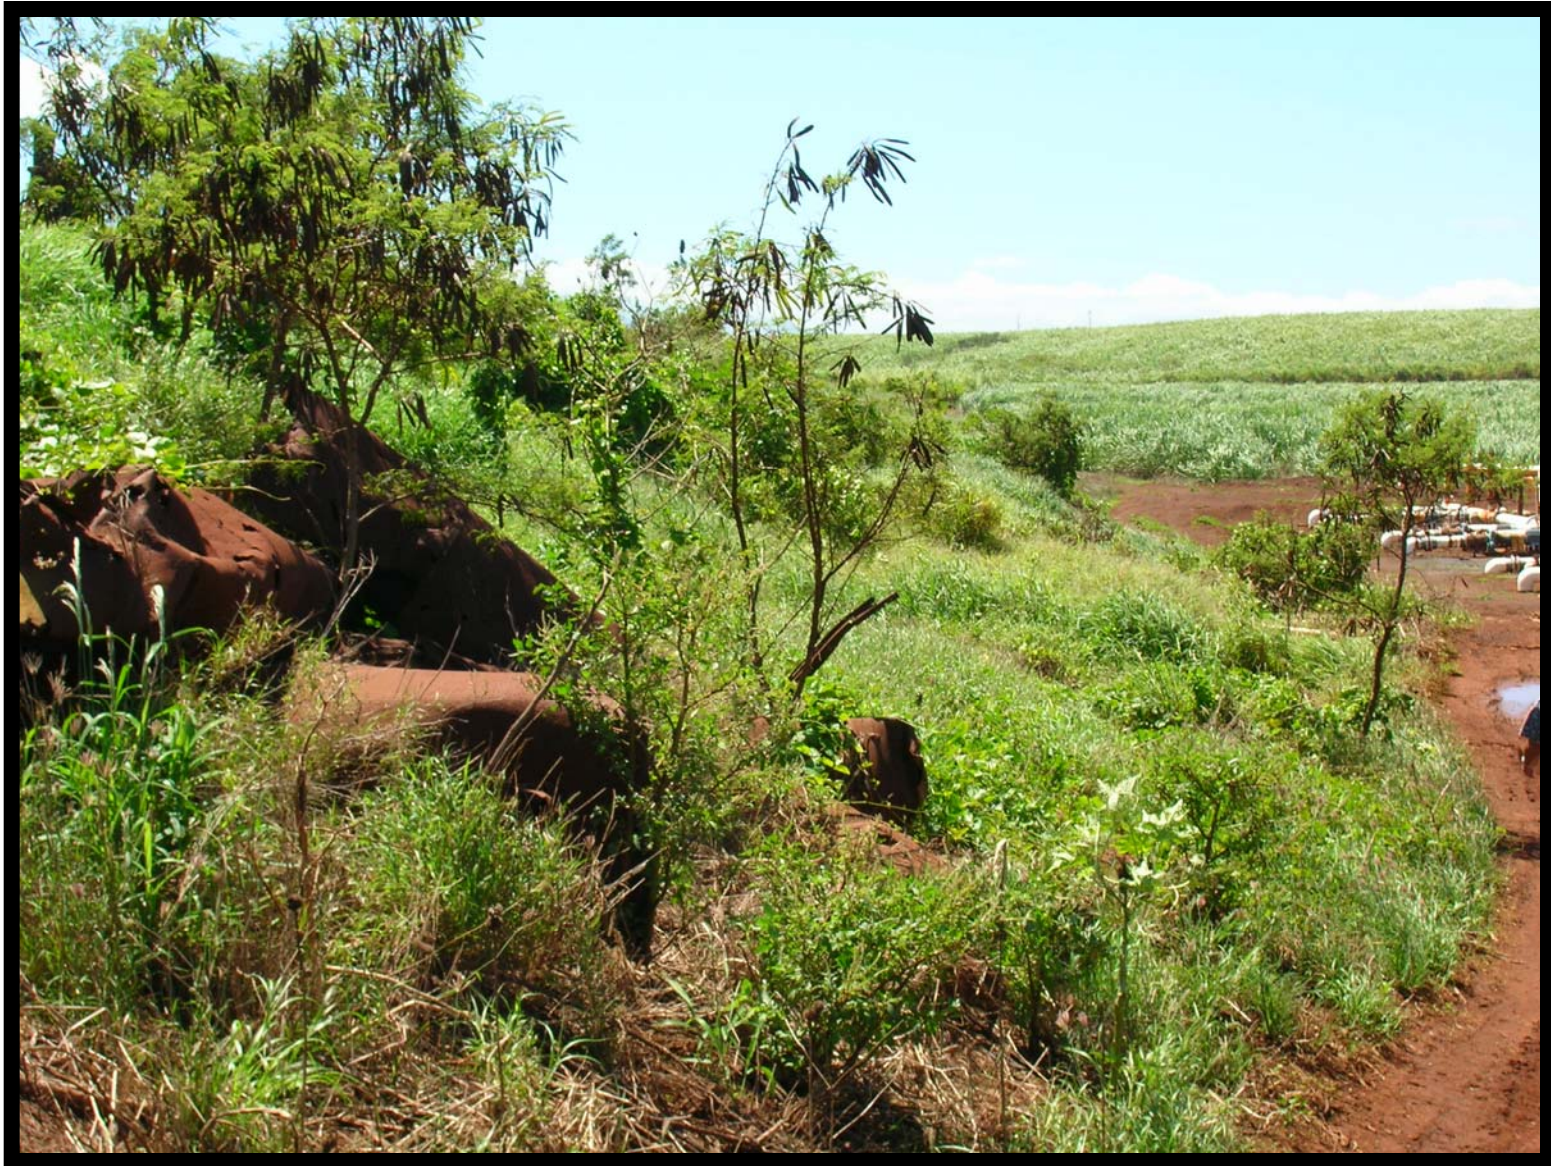
080 downstream slope

The downstream slope was in fair to poor condition and not visible due to heavy vegetation. The slope was very steep, around a 1 on 2 slope.

- a. The downstream slope appeared to be in fair to poor condition and requires corrective action.
- b. Rut and/or Gully erosion was observed on the slope, which requires maintenance and/or repair.

- d. Tree(s) were observed on the downstream slope. Trees have been identified as the probable cause of piping failures, and can possibly cause severe damage to the embankment if they are uprooted during high winds. Corrective action is required to remove the tree hazards from the dam. Acceptable remedies include removal of the tree and its root structure down to a 2" diameter and reconstructing the damaged embankment section. All repair work shall be accomplished as per the requirements of licensed geotechnical or structural engineer. Routinely monitor the damaged area for signs of settlement and seepage.

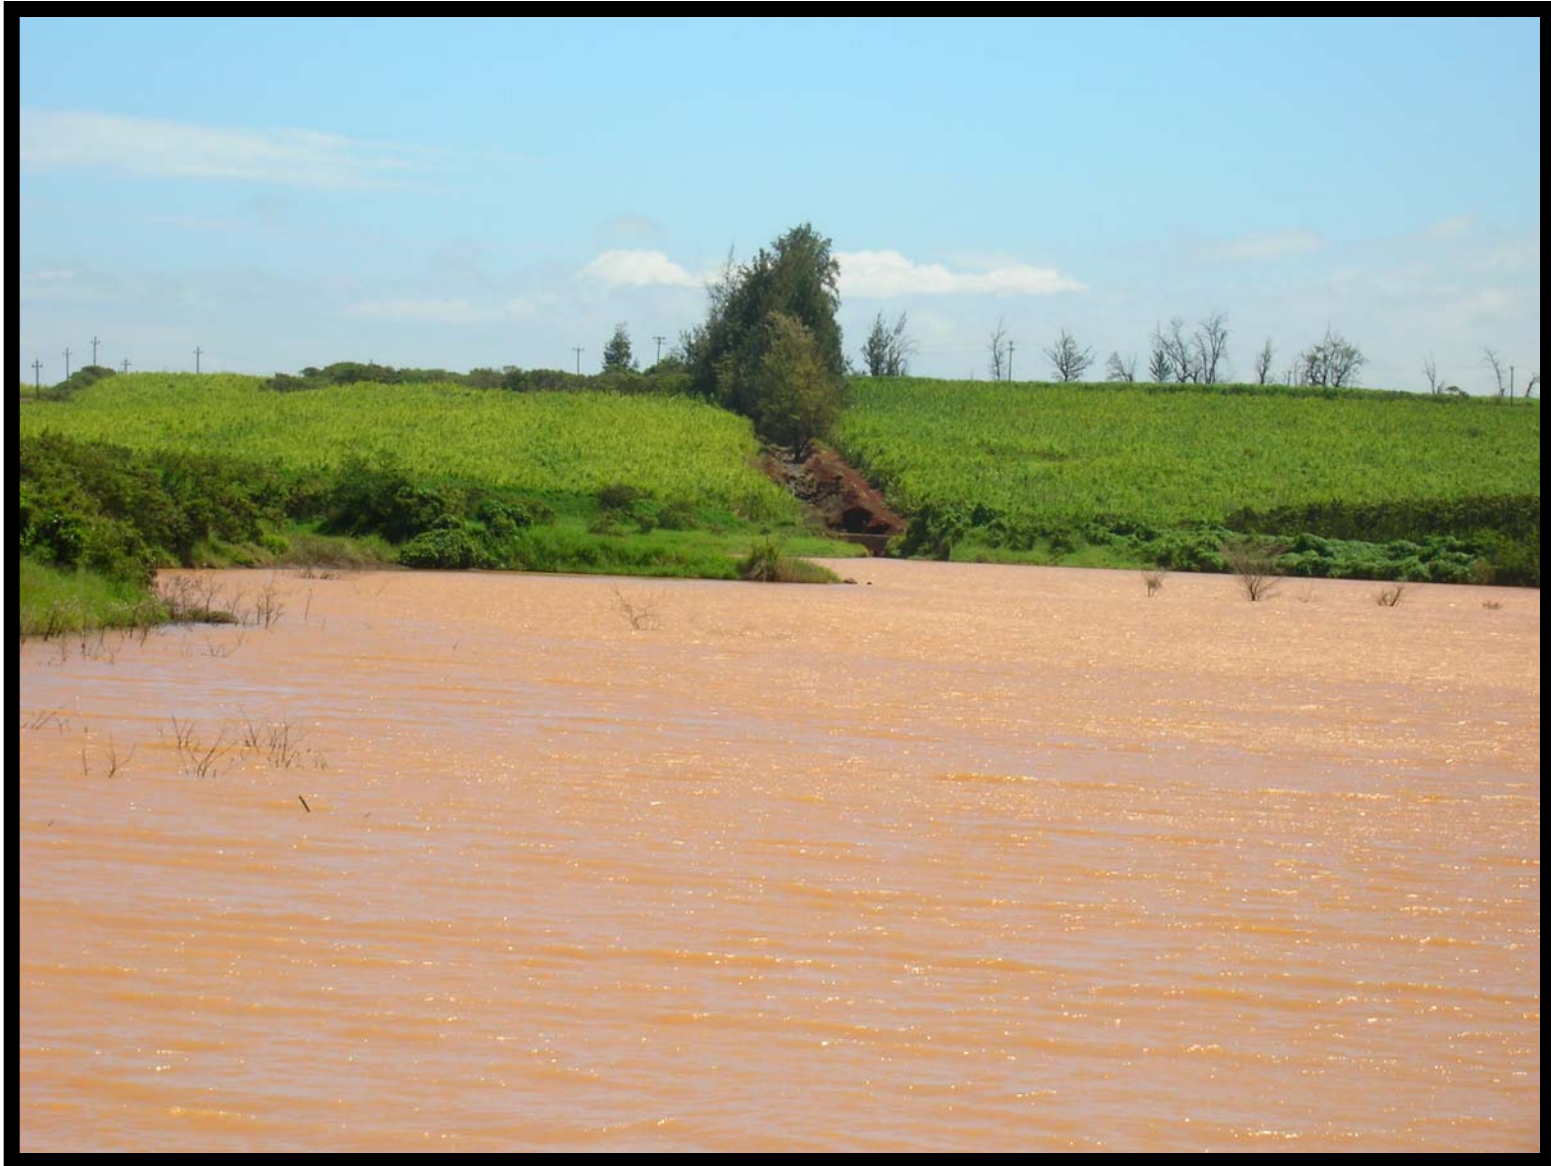
080 inlet

- a. The intake works were not tested.
- b. The intake works appeared to be in satisfactory condition, no corrective actions are required at this time.

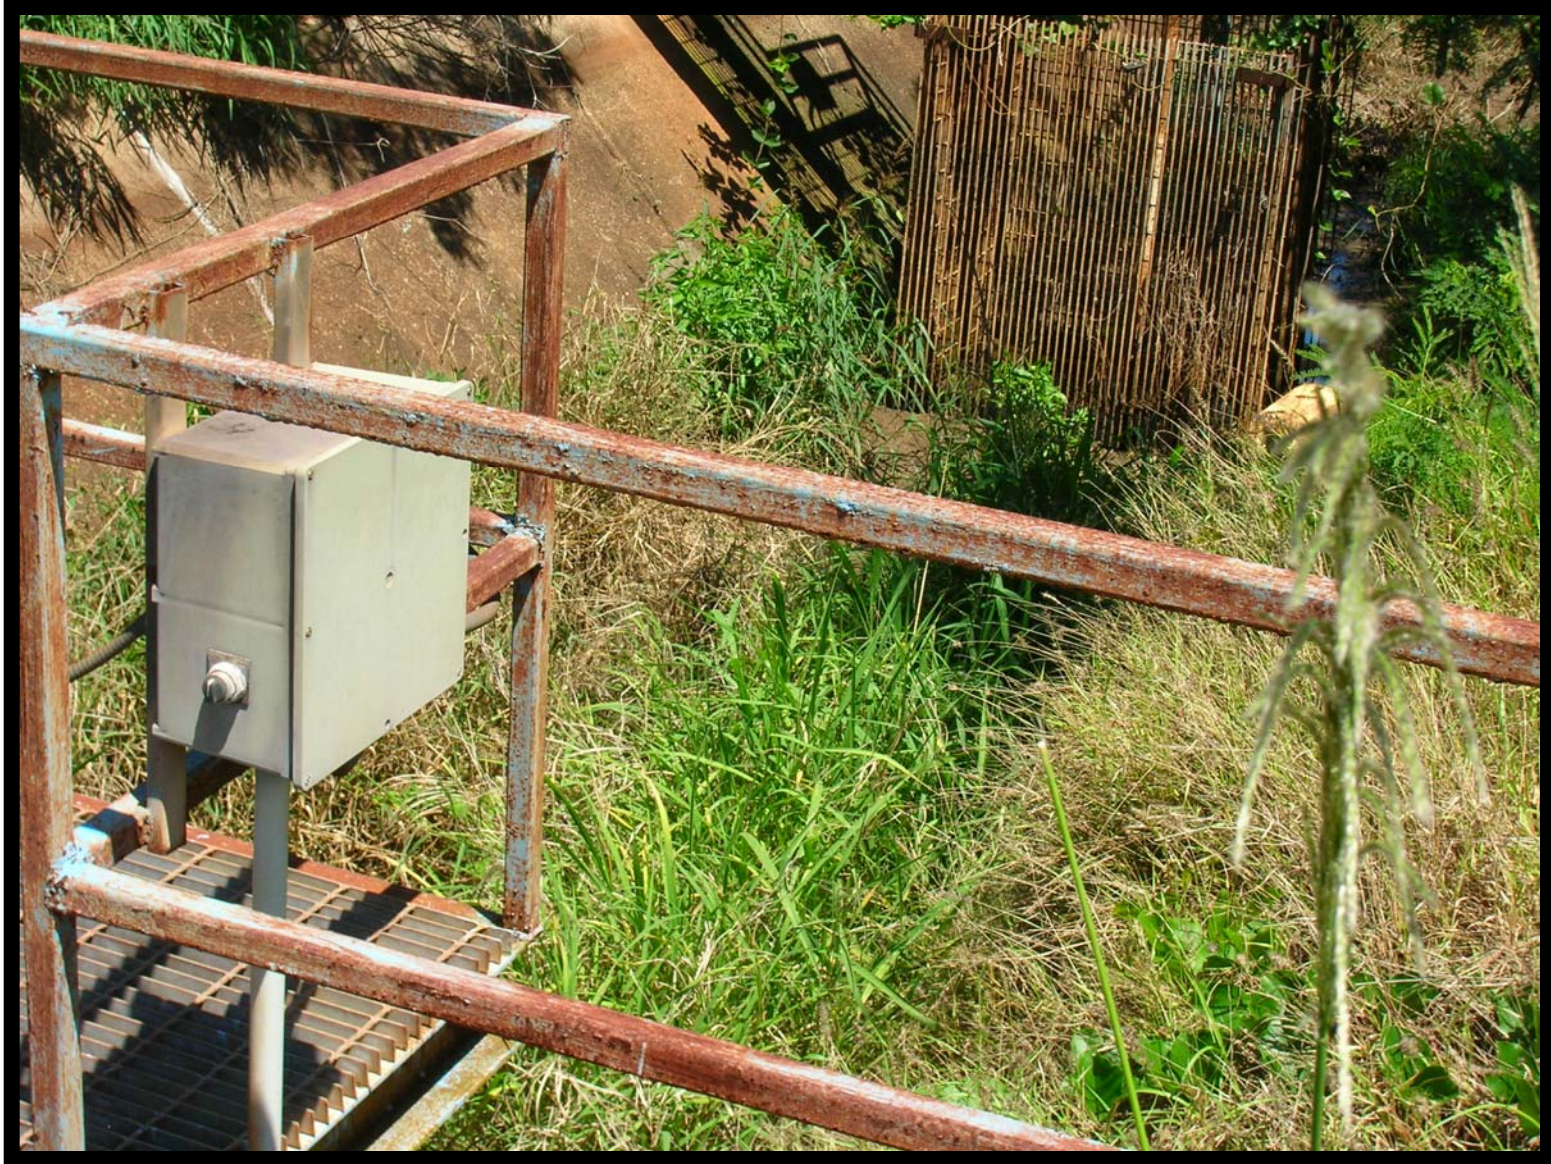
080 outlet

- a. The outlet works were not tested.
- b. The outlet works appeared to be in satisfactory condition, no corrective actions are required at this time.

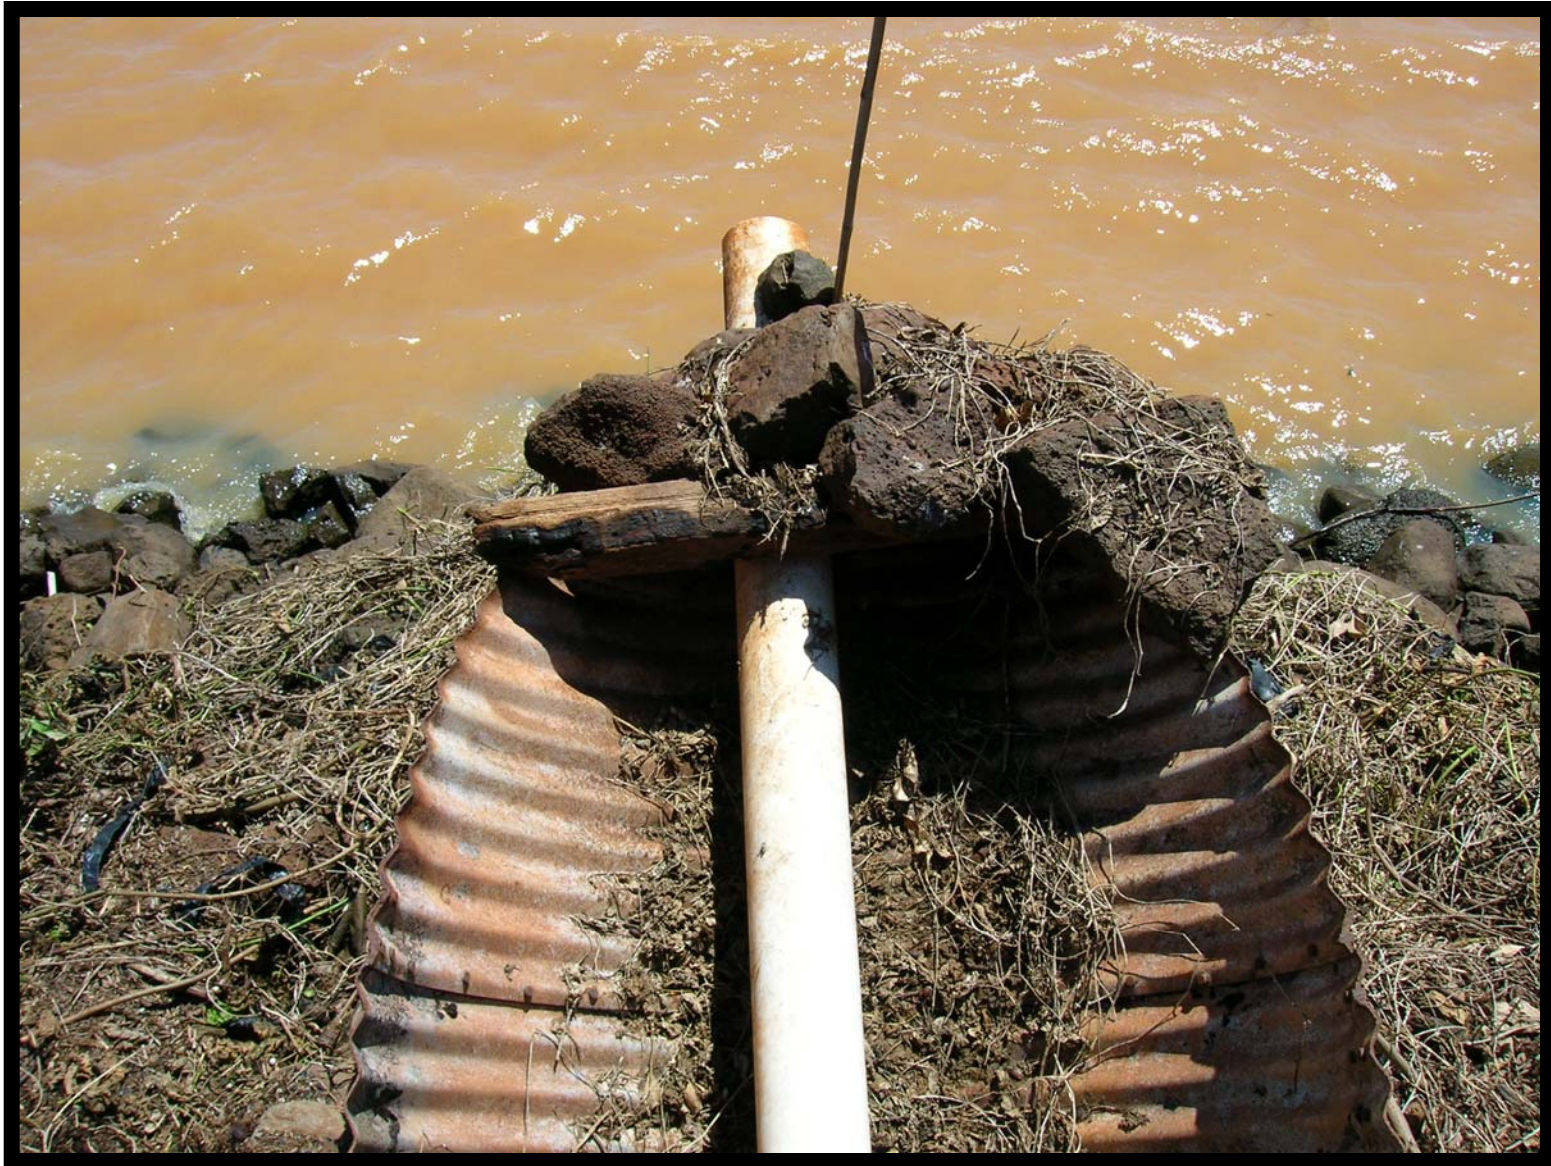
080 spillway

- a. The Spillway appeared to be in fair to poor condition and requires corrective action.
- b. Unclear if spillway is adequately sized. Spillway should pass the probable maximum flood. Verify spillway capacity and take corrective action as required.

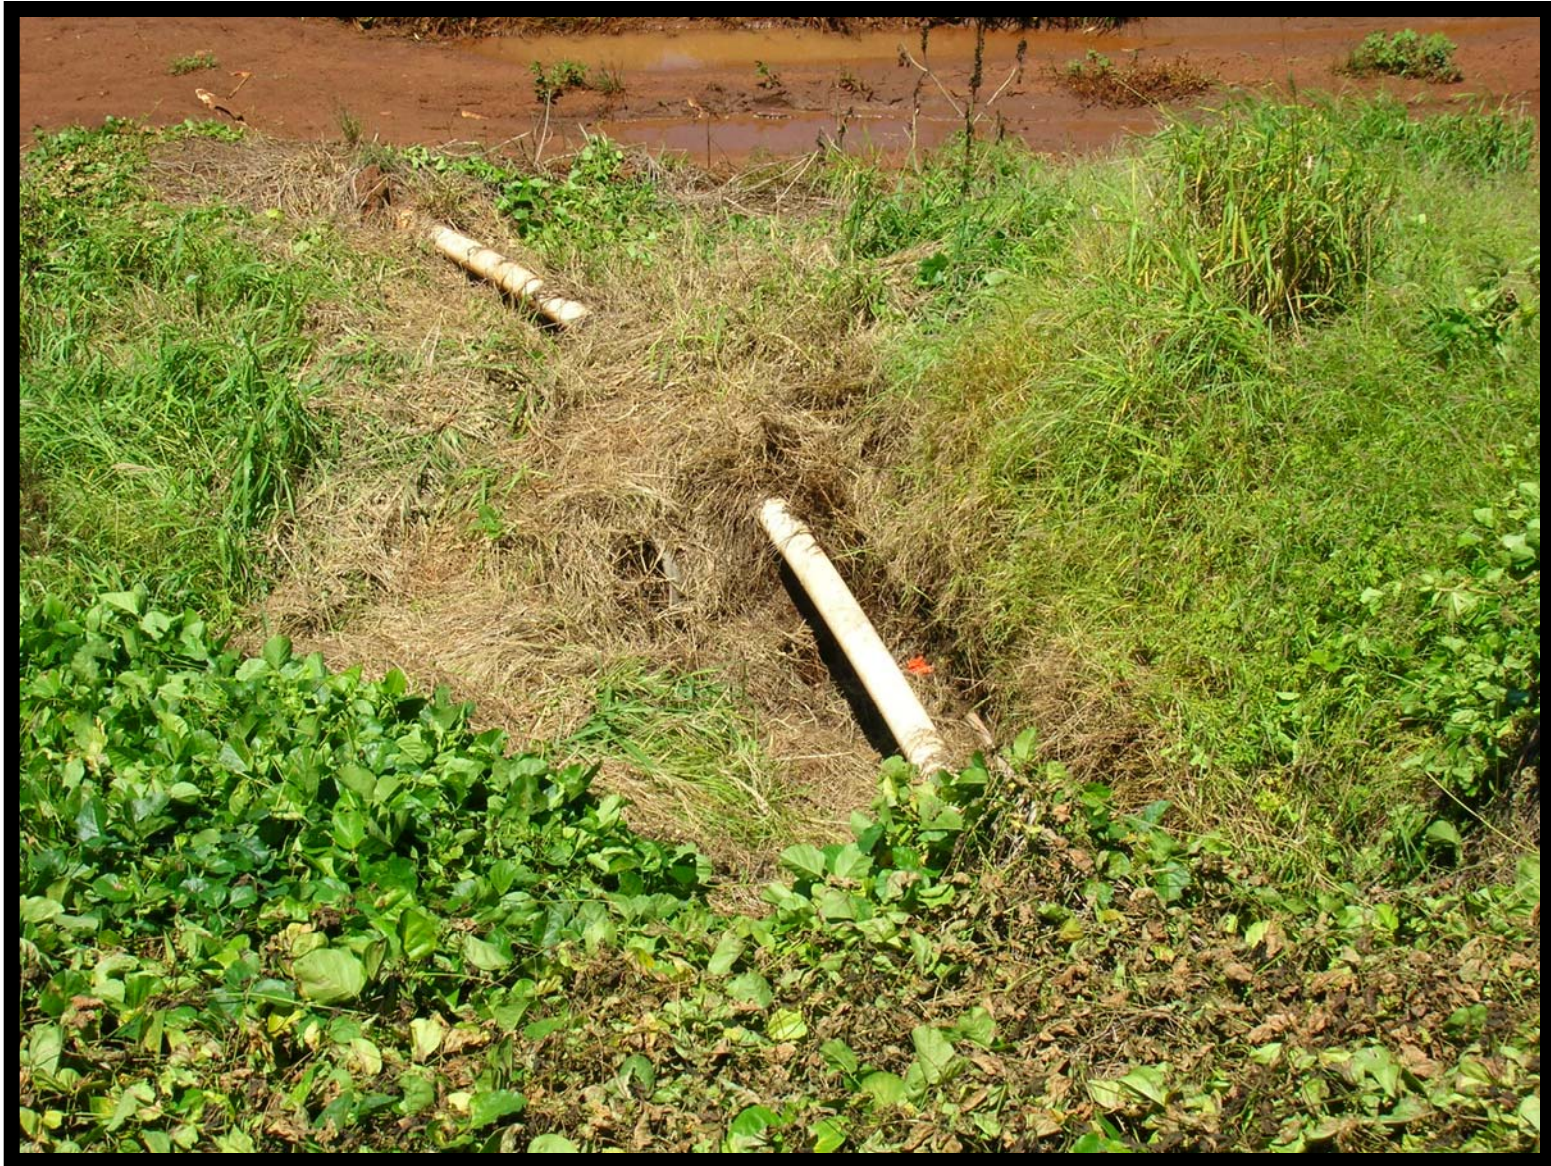
080 spillway outlet

There was headcut erosion observed at the outlet exit.

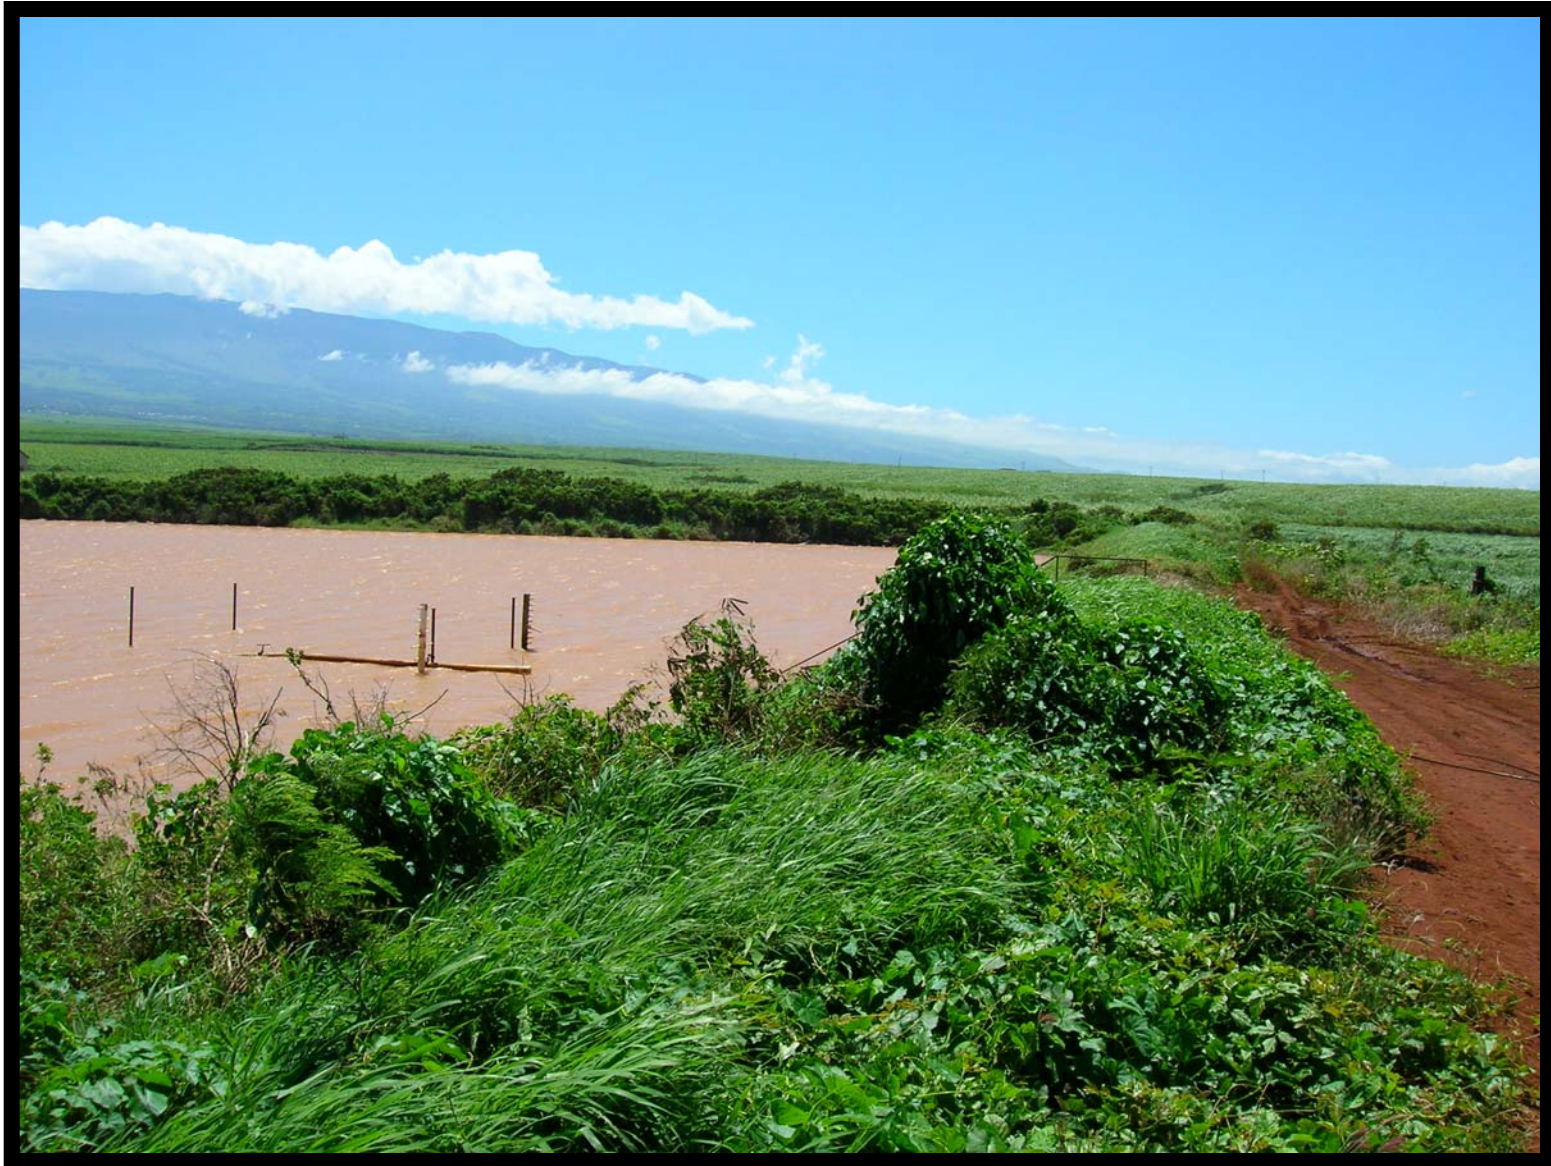
080 upstream slope

A fitted rip rap rock slope protection was observed. Erosions were not visible; the slope was not entirely visible.

- a. The upstream slope appeared to be in fair to poor condition and requires corrective action.
- b. The upstream slope was not visible due to high grass and bush vegetation. Clear high vegetation and maintain low to enable easy visual inspection.
- c. Tree(s) were observed on the dam embankment. Trees have been identified as the probably cause of piping failures, and can possibly cause sever damage to the embankment if they are uprooted during a high winds. Corrective action is required to remove the tree hazards from the dam. Acceptable remedies include removal of the tree and its root structure down to a 2" diameter and reconstructing the damaged embankment section. All repair work shall be accomplished as per the requirements of licensed geotechnical or structural engineer. Routinely monitor the damaged area for signs of settlement and seepage.
